2019-P-02
Coke and Gas Works Exterior Revitalization
ADDENDUM #1

CONDITION ASSESSMENT

The Corporation of the City of Nelson

1051.001

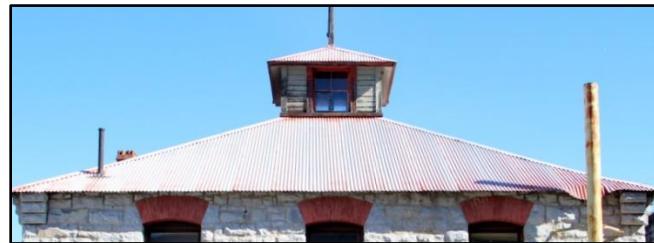
Photograph 4 – The south-west roof with heavily faded, corrugated metal cladding. Note the bent eaves adjacent to the boiler exhaust pipe.

The roof assemblies appeared to be in fair condition with no observed signs of serious deterioration or damage excepting the bent eaves due to snow accumulation against the boiler stack and beneath the chimney where there is reduced structural integrity of the corrugated sheet (Photos C-3 and G-2). The protective coating on the corrugated metal cladding was observed to be fading, especially on the south elevations, but there were no signs of corrosion.

A	Renew the corrugated metal cladding and address the moisture, air, and vapour barriers while providing for intentional ventilation of the attic space.
B	Restore the wood cladding, trim and windows of the cupola.
C	Increase the thickness (and performance) of the ceiling insulation.
D	Complete a structural review of the heavy timber trusses.

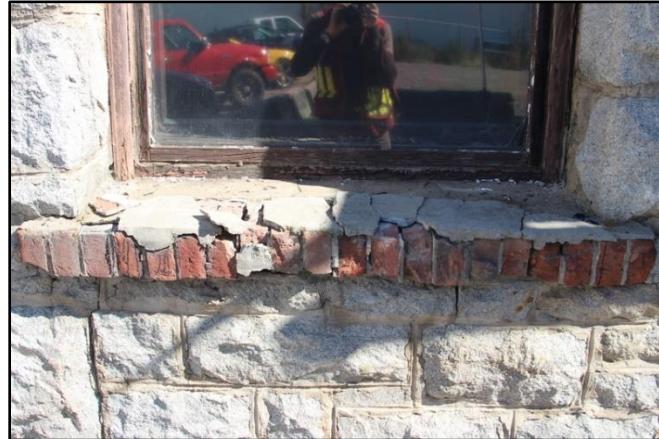
In general, the walls were observed to be in good condition with no signs of material deterioration and / or moisture ingress excepting the severely spalled parging on the clay brick window sills (Photo D-6 & Photograph 6). However, building movement has resulted in a number of cracks on all elevations, some of noteworthy concern.

Photograph 6 – Granite block wall beneath a clay brick window sill with failed parging.

E	Repoint the deteriorated mortar joints and cracks and install crack monitors on the more significant cracks.
F	Renew the window sill parging.
G	Restore the upper, south-east elevation wall (and window).
H	Infill the base of jamb at the upper level door.
I	Remove staining from the granite and clay brick surface.

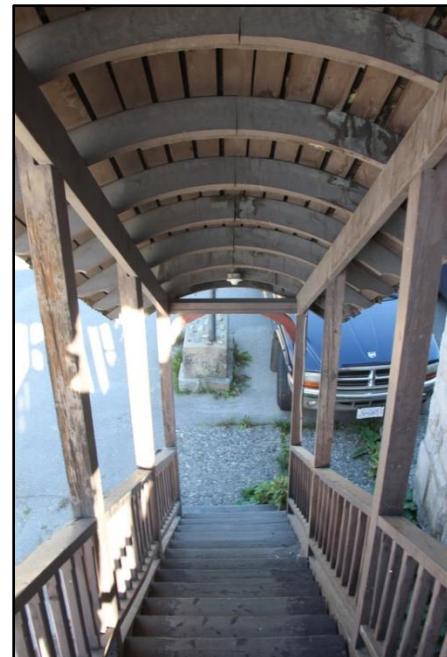
In general, the wood frame staircase was observed to be in fair condition, though plywood walls limited the review of the base. A gap between the upper landing and the stone base suggests the base has, or is, tilting away from the building. This has been addressed with the addition of a second ledger to support the landing (Photo G-9). A number of timber joints in the roof framing are starting to open up indicating movement or shrinkage of the structure (Photos G-7 & G-8). The cedar shingles have also reached the end of their expected service life with a number of them severely deteriorated, especially over the upper landing (Photo G-6). A structural review of the staircase was not completed to determine if it conforms to current code load requirements for the stair, roof or guardrail assemblies.

Photograph 9 – The roof structure, guardrail and steps of the exterior stairs.

It is recommended that the wood frame structure be renewed with all the joints tightened up and any deteriorated elements replaced. The support of the upper landing should be upgraded to ensure a safe landing and then monitored to determine if the stone base is still moving or not. The cedar shingle roof should also be renewed with new fish-scale, cedar shingles, maintaining the characteristic appearance of the curved roof. A fresh coat of paint would enhance the appearance of the stairs and provide additional protection to the wood framing. If the stair is to be utilized as a primary access point for the second level, and subsequently a fire escape route, a review of its structural integrity is recommended.

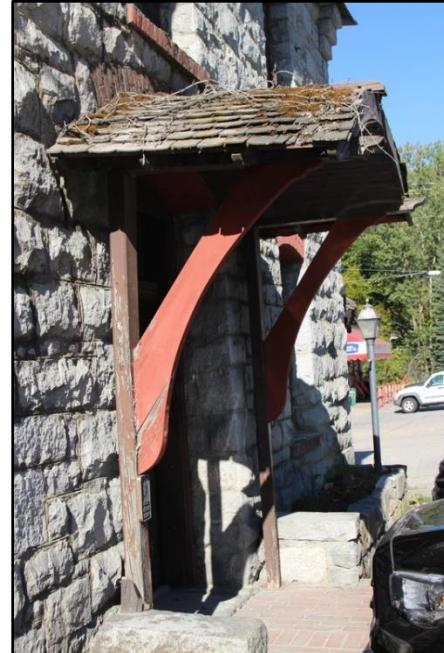
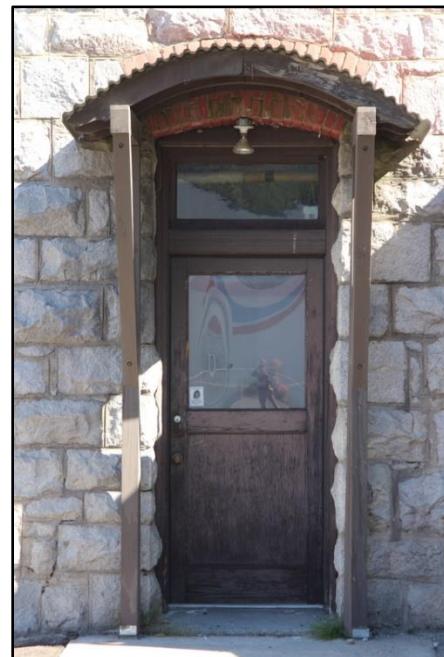
Both canopies appeared to be in fair condition with the front canopy, likely due to age, showing signs of more advanced deterioration. The front posts are set directly on grade and as such are decaying at the base. This has resulted in a vertical displacement of the left post and damage to the supported beam. The right side post is split, potentially compromising its structural integrity. Past plant growth and bird nests were observed in the roof assembly which was also noted to be draining against the building. The outer roof battens were also starting to deteriorate with the protective shingles having exceeded their expected service. The back canopy, although lacking the historic character of the front canopy, appeared sound with only the right post having twisted and starting to crack.

Photographs 10 & 11 – The original front and contemporary back canopies.

It is recommended that both canopies be renewed, addressing the damaged posts by replacing them if necessary. The front canopy requires a new shingle roof and repairs made to the deteriorated rafters and battens.

The back canopy does not require any restorative work at this time though the twisted post should be monitored. If desired, the back canopy could be reconstructed with a design and materials that better match the front canopy including the utilization of a cedar shingle roof. Both canopies should have flashing installed where they come in contact with the building, diverting moisture runoff away from the building walls. Both canopies would also benefit with the renewal of the protective coating of paint.

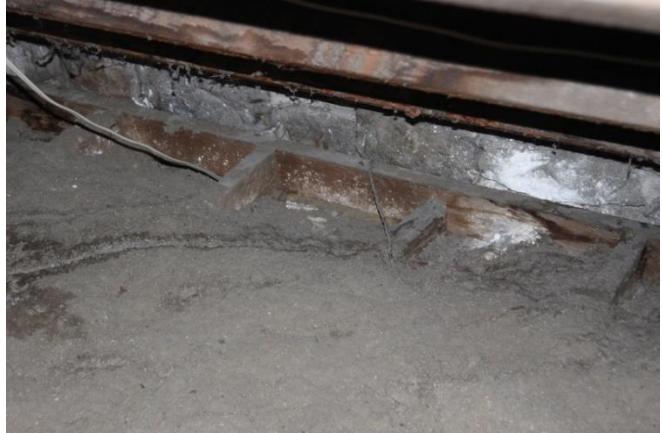
Photo C-15

Table C – Roof Assembly Observations	
Tell-tale stain lines showing that water leaks through the main roof along the edges of the shiplap planks. The deterioration appeared to be limited to staining with no ceiling deterioration observed.

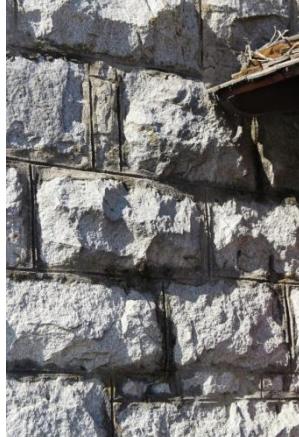
Photo D-4
<p>Staining on the granite wall to the right of the front entrance canopy.</p>

Photo D-3
<p>A crack in the clay brick arch over the front door indicating movement in the arch.</p>

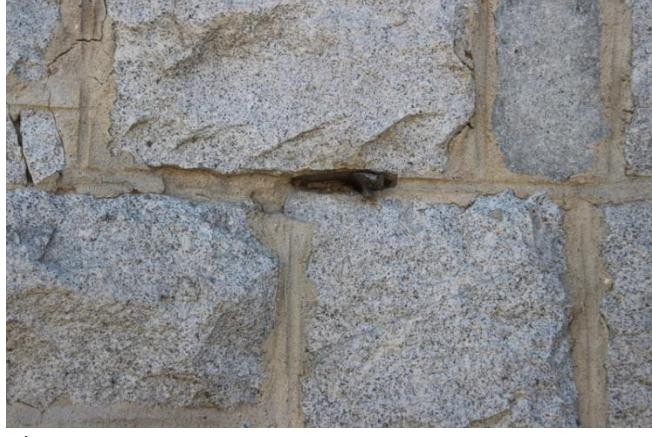
<p>Photo D-8</p>

<p>Photo D-7</p>
<p>A crack in the granite wall between the clay brick sill and arch.</p>

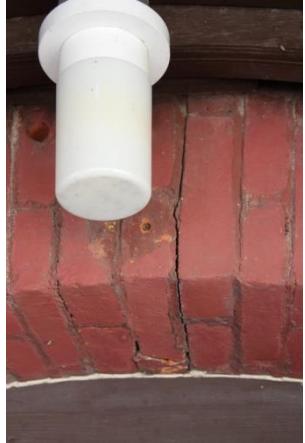
Table D – Wall Assembly Observations	
A crack in an upper level window arch.

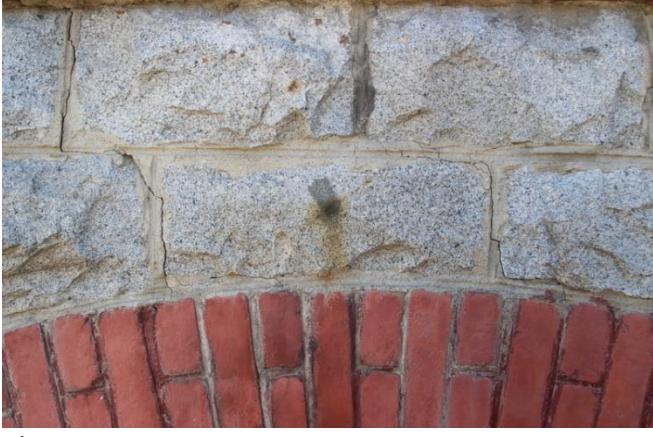
Photo D-13
Cracked mortar and delaminated cementitious parging. Note the blocked vent to the crawlspace.

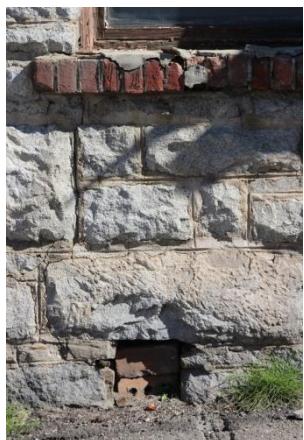
Table D – Wall Assembly Observations	
Poorly applied and cracked masonry mortar.

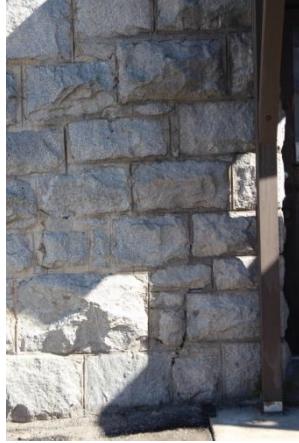
Photo D-15
Poorly applied and cracked masonry mortar with shrinkage cracks.

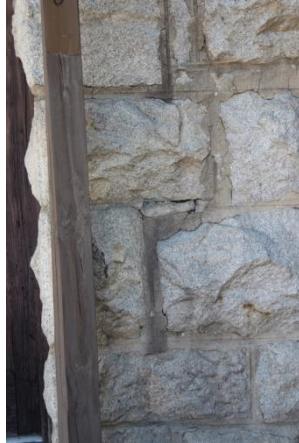
Photo D-16
Corroding iron inclusions in the granite stone.

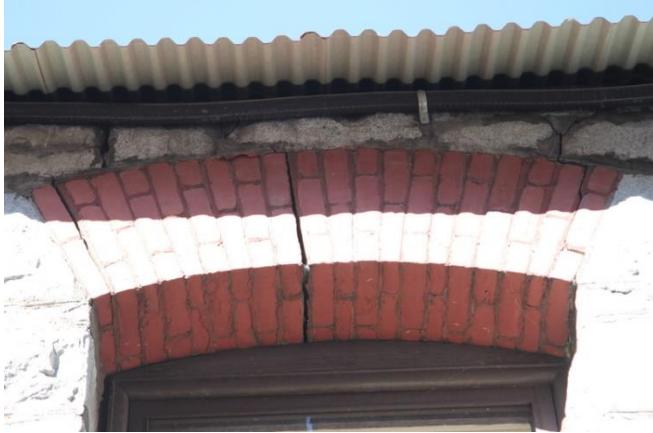
The largest cracks were observed on the south-east elevation where a 25mm vertical gap has opened up between the upper and lower windows. This gap reduces in width nearer both the roof and grade (Photos D-18 – D-20). Further, it does not manifest itself on the interior finishes which are understood to have been in place for over 35 years (Photo D-25). A number of smaller cracks extending down to grade were observed closer to the east corner of the wall. The upper central window of this elevation was replaced with two contemporary windows requiring a portion of the granite wall to be in-filled. The mortar joints of this area were not properly tooled resulting in a rough finish (Photo D-22). Above the new windows, a concrete lintel was poured and concrete blocks were used to infill the void in the wall, rather than the original granite blocks and clay brick arch (Photo E-8).

Photo D-18
A significant crack between a window sill and an arch immediately below.

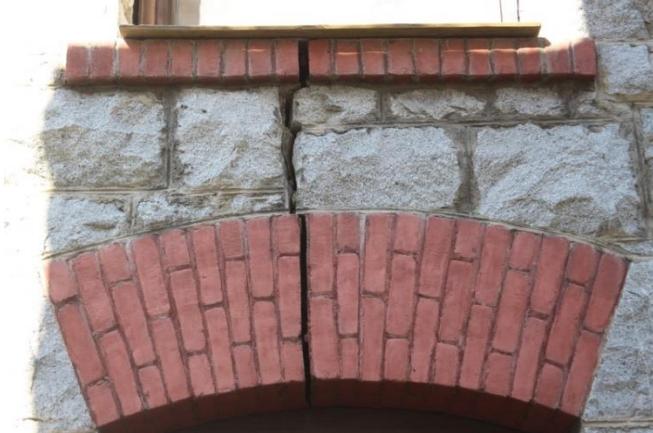
Photo D-19
Minor cracking through the grade level sill beneath the significant crack suggesting differential wall movement.

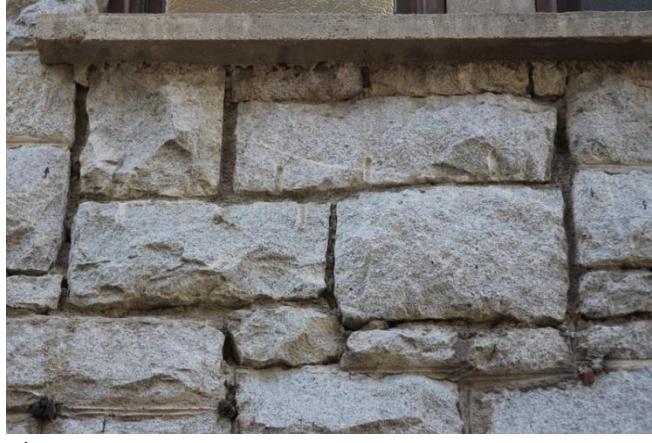
<p>Photo D-22</p>
Cracked mortar joints in granite masonry. Note the penny rolled mortar profile.

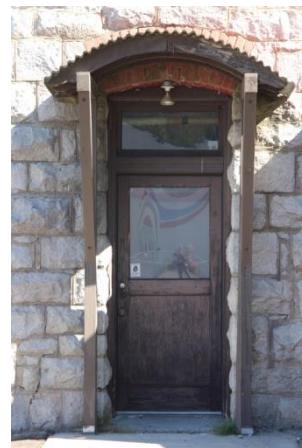
Deterioration at the base of a door – south-west elevation.

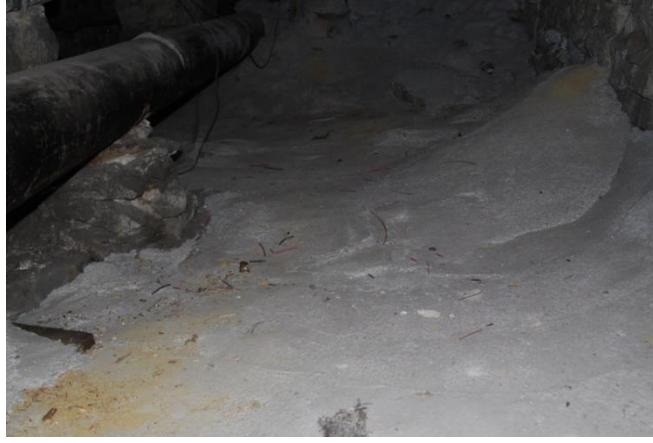
Table F – Foundation Assembly Observations		
A partially blocked vent at grade connecting the crawlspace to the exterior.

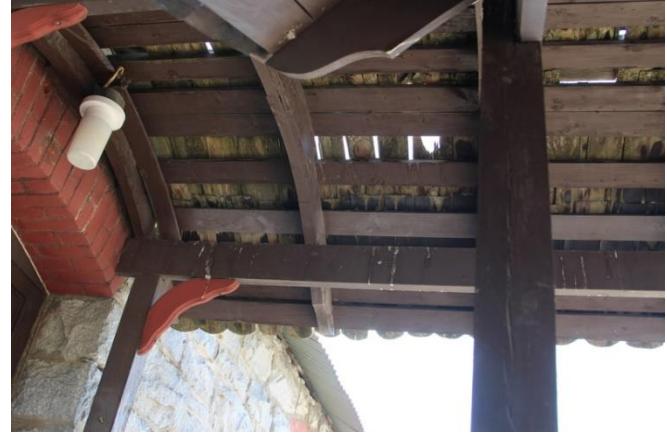
<p>Photo G-6</p>
<p>A joint in the upper wood frame structure starting to warp out of position.</p>

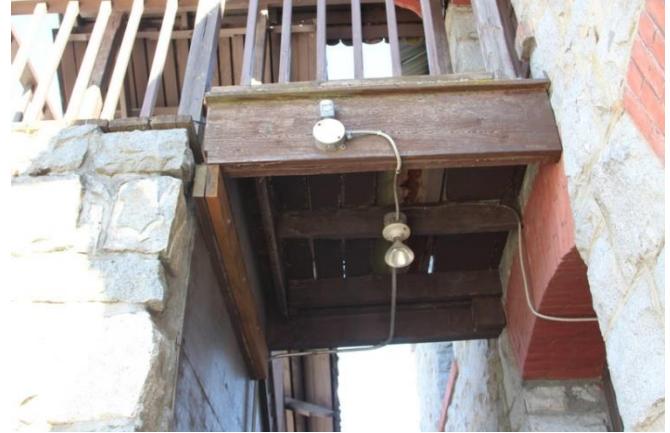
<p>Photo G-9</p>
<p>The original front entrance canopy with curved rafters and a wood soffit.</p>

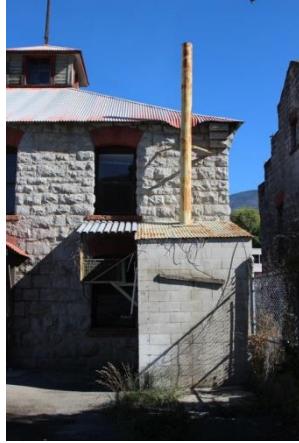
Photo G-21
<p>A gap between the concrete block structure and the original building suggesting the shed is rotating away from the building.</p>
