City of Nelson
80 Lakeside Drive
Nelson, BC V1L 6B9

OUR REFERENCE:
700667

Subject: Nelson Curling Rink – Geotechnical Investigation

July 15, 2024

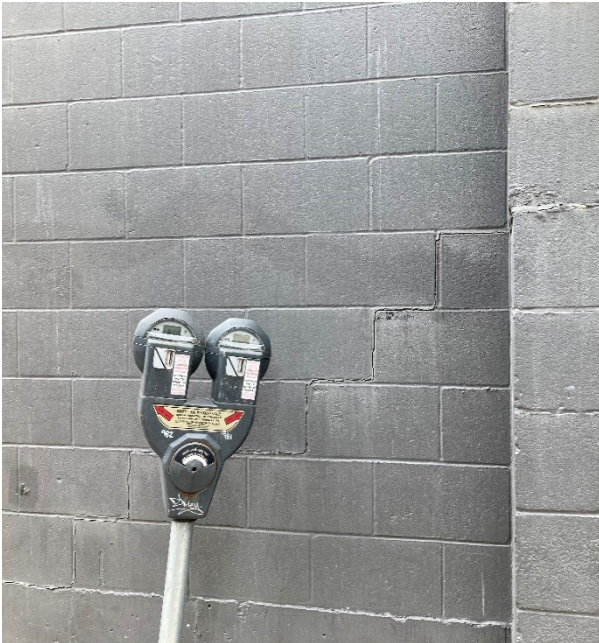
During the preliminary Site visit, cracking of the Curling Rink was observed primarily along the north and east walls, with more prominent cracks visible towards the northeast corner of the building. Cracking was observed in the mortar between masonry blocks and in the concrete foundation and was visible from both the exterior (Photograph 1) and interior of the Curling Rink. Cracking was also observed from inside the Equipment Refrigeration Room along its south wall (Photograph 2). Figure 2 in the following subsection (Section 2.2) provides a general representation of the walls where cracking was observed.

Photograph 1: Cracking of Mortar Between Masonry Blocks on East Curling Rink Wall – Facing West

- **Survey and Crack Monitoring:** Survey monuments may be installed at select locations around and/or on the Curling Rink structure to allow for accurate measurement of potential displacements and displacement rates at the Site. Crack monitors may be installed at known cracks in the building walls to quantifiably assess direction and rate of movement;

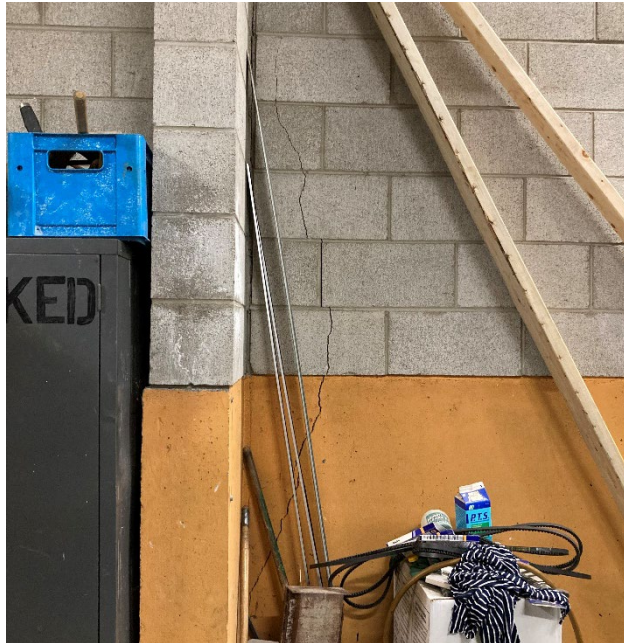
Photograph 2: Cracking Inside Refrigeration Equipment Room (South Wall) – Facing South

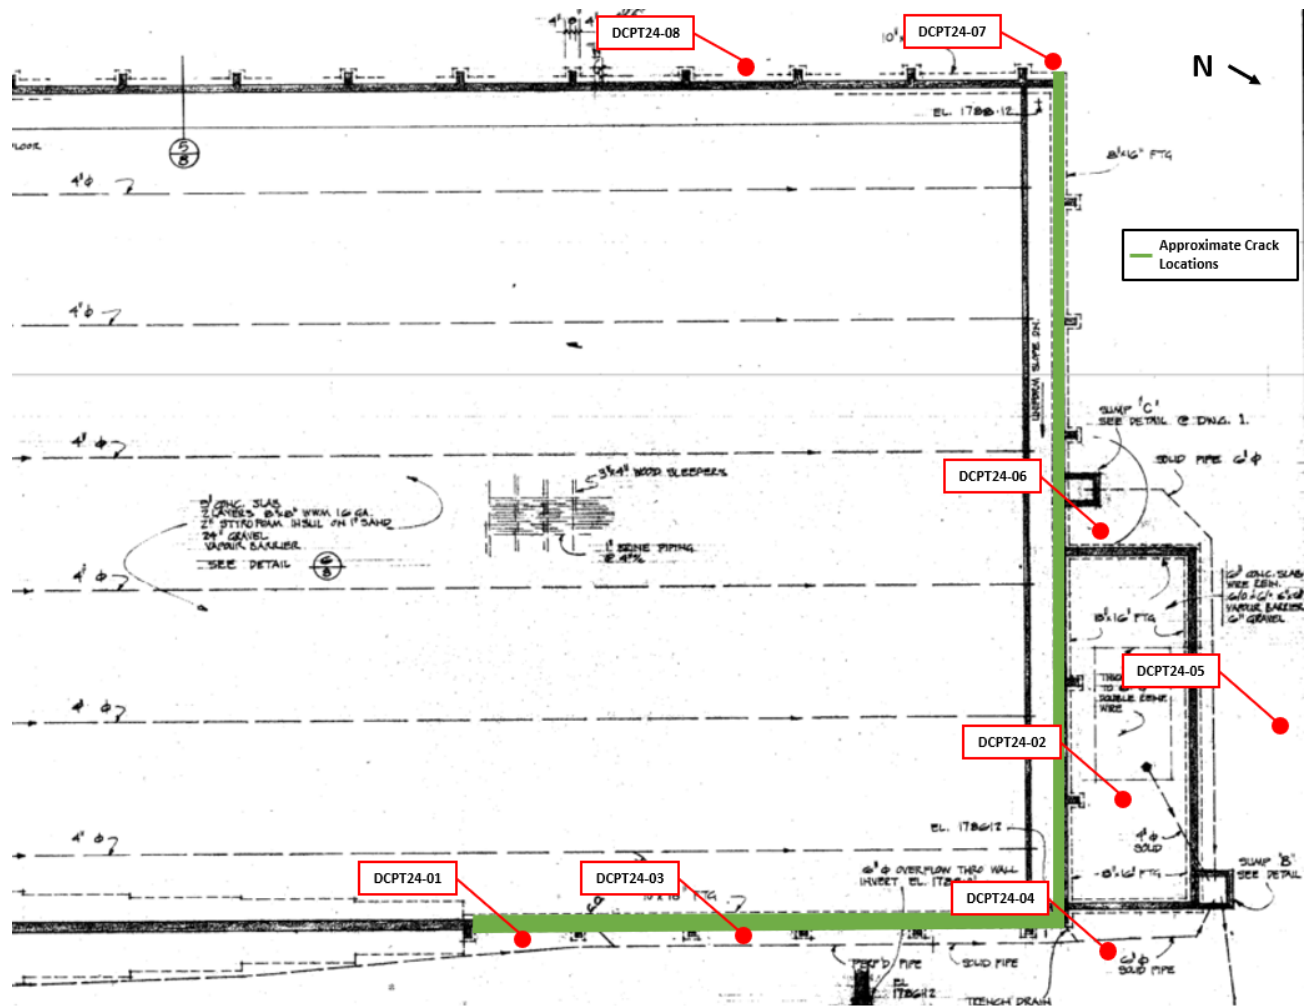
Figure 2: Approximate DCP Test Hole and Crack Locations (excerpt from DWG 2 – Foundation Plan & Details)

In general, DCPT24-01 and DCPT24-08, which were located the furthest south of the tests completed exhibited the greatest strength (DCPT24-01) and shallowest depth to very stiff subgrade conditions (0.6 m at DCPT24-08). Conversely the three tests located at the east end of the north wall were noted to be soft to very firm to depths ranging between 1.7 m and 2.3 m below the estimated depth to footing.

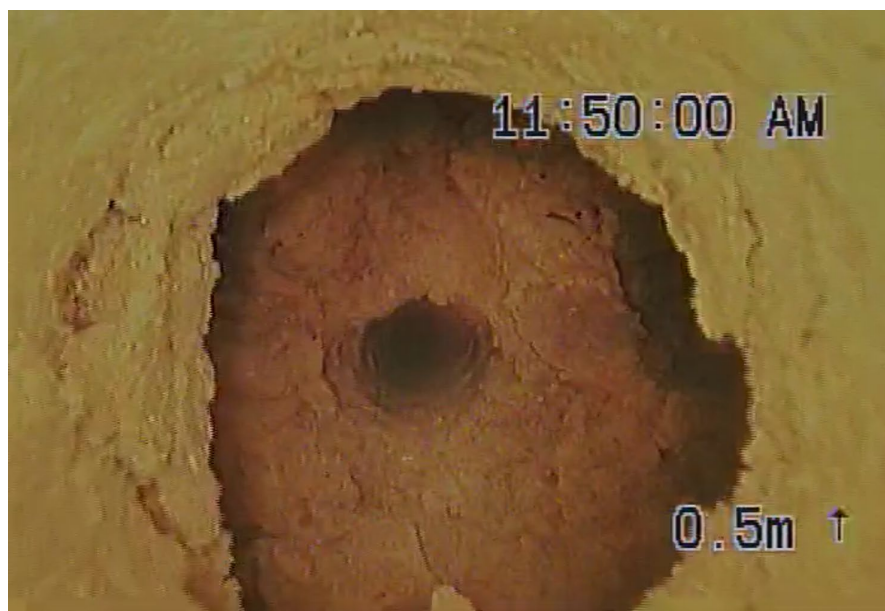
In DCPT24-02, an approximately 200 mm void was encountered, and its presence confirmed by City representatives using a small diameter downhole camera, directly above the estimated footing depth. A screenshot of the void taken from the downhole camera video recording is shown in Figure 3, below; the depth shown in Figure 3 is inconsistent (variance of 0.5 m) with the depth the void was encountered during DCP testing. Below the assumed footing depth, SPT N values ranged between 0 and 6 (very soft to firm) for approximately 2.2 m. The final approximately 2.2 m of DCPT24-02 was observed to be stiff to very stiff. AtkinsRéalis returned to the Site on June 14, 2024, to take a water level reading in the installed MW, which was observed to be dry at the time of the reading.

Figure 3: Screenshot of DCPT24-02 Void Taken from Downhole Camera Video Recording

The void observed below the Refrigeration Equipment Room in DCPT24-02 indicates that potential piping failures may be occurring below the floor slab. Piping failures occur when groundwater seepage through preferential pathways cause internal erosion by washing away fine-grained soil particles, which has a compounding effect over time. Piping failures leave behind voids in soils along the pathways created by the water flow. This can lead to additional deformations as soils settle into the voids, which may then be

- **More Camera Investigation:** A camera could be used to further investigate the void discovered in DCPT24-02. Should the void be the cause of a piping failure (Section 4.1.2), a camera may assist in determining the source location of water;

- **Pressure Grouting:** Pressure grouting may be implemented at the Site in an attempt to fill the void discovered in DCPT24-02 and add some additional strength to the subsurface soils. However, during pressure grouting it can be difficult to control where the grout ends up as it will choose the path of least resistance in the soil. Grout may enter existing perimeter drainage (if present) and large volumes of grout may be required; and
