2019-P-02
Coke and Gas Works Exterior Revitalization
ADDENDUM #1

CONDITION ASSESSMENT

The Corporation of the City of Nelson

1051.001

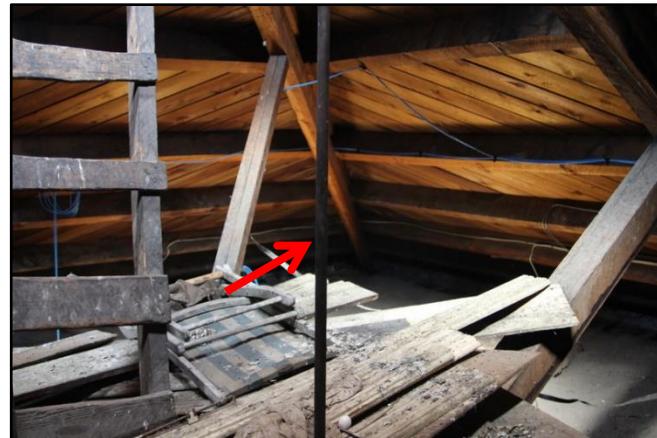
Photograph 5 – The heavy timber roof structure with horizontal purlins and shiplap planks. Note the central steel tie rod.

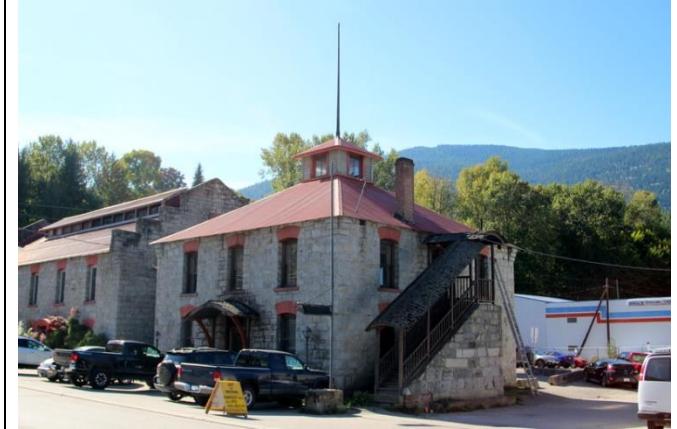
<p>Photo C-1</p>
<p>The wood frame cupola with 2 over 2 lite, wood frame windows and wood siding beneath the protective corrugated metal roof. The wood spire projects from within the cupola through the roof assembly.</p>

<p>The north corner of the building showing the wood spire above the cupola, the red, corrugated metal roof, the clay brick chimney and the wood frame stairs to the upper floor.</p>

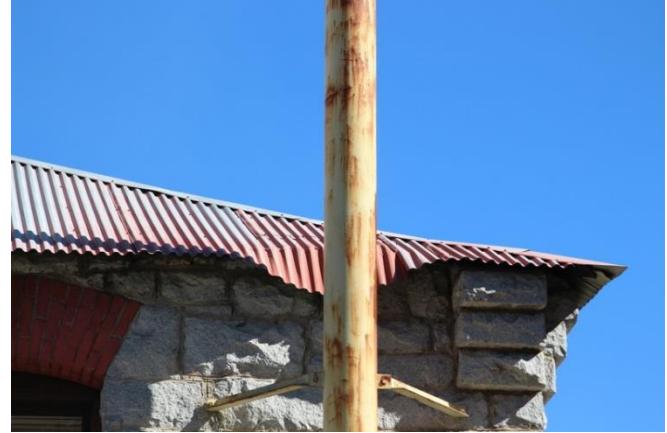
<p>Photo C-3</p>
<p>The 2x4 and shiplap plank roof structure of the cupola supported by a central post that extends out as the wood spire.</p>

The roof assemblies appeared to be in fair condition with no observed signs of serious deterioration or damage excepting the bent eaves due to snow accumulation against the boiler stack and beneath the chimney where there is reduced structural integrity of the corrugated sheet (Photos C-3 and G-2). The protective coating on the corrugated metal cladding was observed to be fading, especially on the south elevations, but there were no signs of corrosion.

<p>The unsupported eaves of the corrugated metal roof having bent beneath previous snow load accumulations.</p>

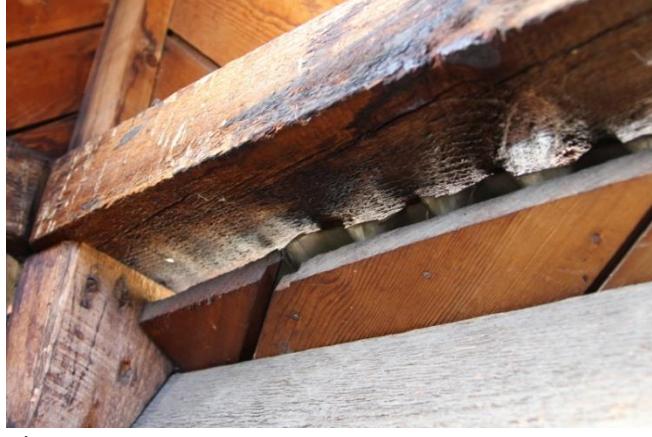
Photo C-7
The heavy timber rafters of the main roof structure supporting the central post that extends through the cupola roof structure. Note the heavy steel plate between the post and the rafter ends.

The timber structure and shiplap planks appeared to be in good condition excepting the signs of moisture staining where water is making its way through the assembly. This is particularly evident at the base of the cupola where there is a significant gap between the base plate and the main roof assembly (Photo C-7). Further evidence of moisture ingress is revealed with staining patterns on the insulation showing water dripping from the edges of the shiplap planks (Photo C-15). The venting of the attic space appeared to be adequate with vents set in the upper walls above the ceiling structure (Photo D-10) and the unintentional gaps in the cupola. Aside from observing the sound appearance of the timber structure, a structural analysis was not completed to determine if the roof would be able to meet current building code load requirements.

Photo C-6
The baseplate of the cupola wall structure supported over the central opening of the main roof. Note the gap between the baseplate and the corrugated, metal roof.

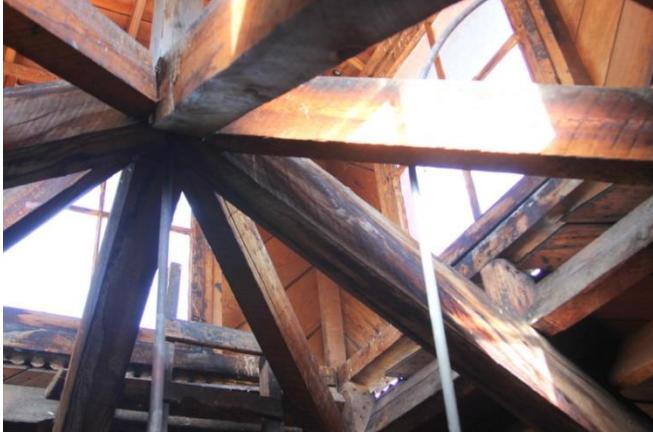
Photo C-9
The heavy timber purlins supporting the shiplap roof planks while being supported by the heavy timber rafters.

From the attic space, the heavy timber roof structure was observed to be set on the granite walls. Eight rafters extend up to a single point (Photo C-9), one each from the corners and one each from the centre of the walls. These rafters are each supported by central braces (Photo C-11) which all come together to a single inverted point beneath the rafter point. These points are then tied together with a heavy steel rod forming the primary roof structure (Photograph 5). On these rafters are set purlins which in turn support the sloped shiplap planks beneath the corrugated metal roof (Photo C-10). Set on the upper end of the rafters is the cupola wall structure with a lighter timber base plate and wall studs supporting a light framed roof assembly, all beneath

Table C – Roof Assembly Observations	
The eight, heavy timber roof rafters of the main roof coming together to a single point.

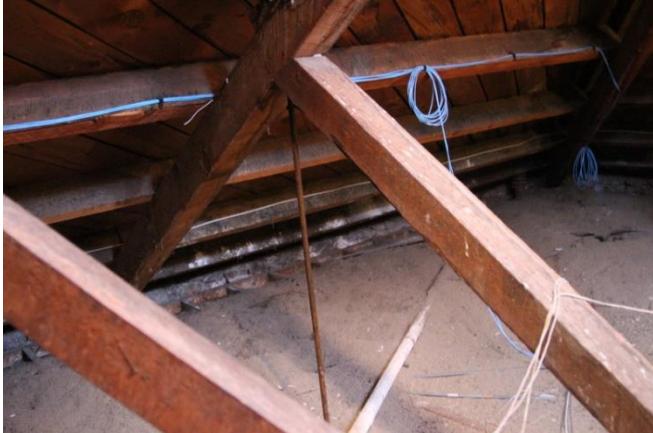
Photo C-11

Photo C-10
A support brace for the heavy timber roof rafters. Note the vertical metal tie rod supporting the bottom chord of the truss.

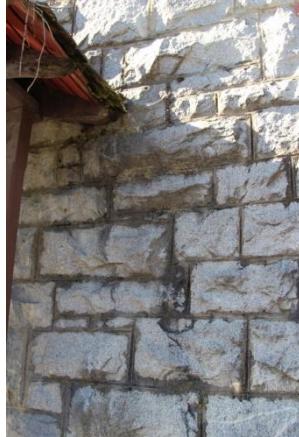
Photo D-5

was never infilled. Additional staining was observed on either side of the front canopy from moisture running off the canopy roof and down the wall.

Photo D-4
<p>Staining on the granite wall to the right of the front entrance canopy.</p>

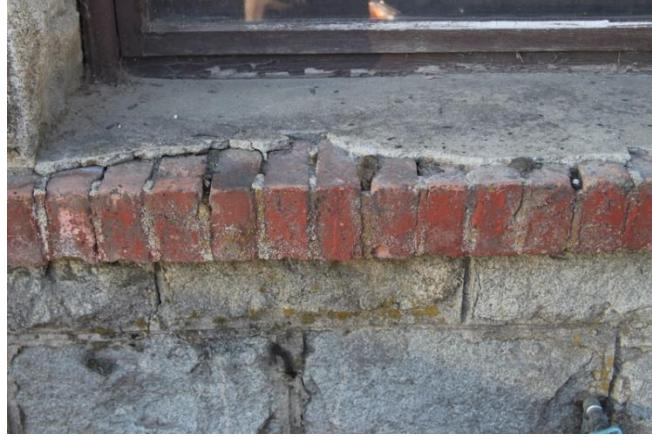
<p>Photo D-6</p>
<p>A wood wedge set in the mortar joint - sometimes used to level the masonry unit during placement or sometimes utilized to receive fasteners in the more joint.</p>

In general, the walls were observed to be in good condition with no signs of material deterioration and / or moisture ingress excepting the severely spalled parging on the clay brick window sills (Photo D-6 & Photograph 6). However, building movement has resulted in a number of cracks on all elevations, some of noteworthy concern.

<p>A typical clay brick window sill with delaminating, cementitious parging on the surface.</p>

E	Repoint the deteriorated mortar joints and cracks and install crack monitors on the more significant cracks.
F	Renew the window sill parging.
G	Restore the upper, south-east elevation wall (and window).
H	Infill the base of jamb at the upper level door.
I	Remove staining from the granite and clay brick surface.

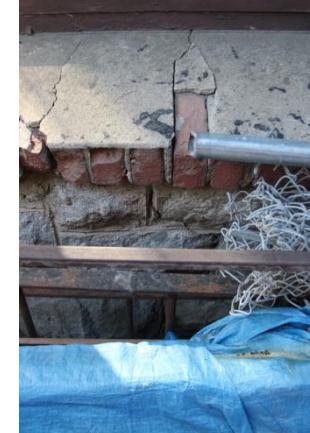
Photo D-20

The largest cracks were observed on the south-east elevation where a 25mm vertical gap has opened up between the upper and lower windows. This gap reduces in width nearer both the roof and grade (Photos D-18 – D-20). Further, it does not manifest itself on the interior finishes which are understood to have been in place for over 35 years (Photo D-25). A number of smaller cracks extending down to grade were observed closer to the east corner of the wall. The upper central window of this elevation was replaced with two contemporary windows requiring a portion of the granite wall to be in-filled. The mortar joints of this area were not properly tooled resulting in a rough finish (Photo D-22). Above the new windows, a concrete lintel was poured and concrete blocks were used to infill the void in the wall, rather than the original granite blocks and clay brick arch (Photo E-8).

Photo D-19
Minor cracking through the grade level sill beneath the significant crack suggesting differential wall movement.

It is recommended that the mortar joints be repointed where necessary, including the infilling of all cracks, and those cracks that are deemed to be significant be monitored for recurrence and if necessary, rate and direction of motion. Only then can a proper course of action be determined to alleviate building movement. The window sill parging should also be restored with an appropriate mortar that resists the ingress of moisture into the clay brick window sills. If possible, the historic character of the building should be restored with the reinstatement of the original upper central window and the surrounding granite block walls and clay brick detailing on the south-east elevation. Understanding that the south-west stair has become a character defining feature, the upper level door should simply be refinished and the jamb base filled with a granite block (the embedded clay brick being a characteristic feature that can be retained). Any minor wall staining can be cleaned to improve building aesthetics.

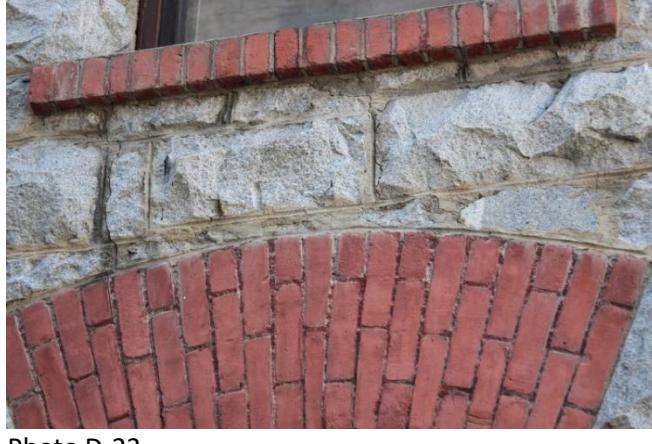
<p>Photo D-23</p>

<p>Photo D-22</p>
Cracked mortar joints in granite masonry. Note the penny rolled mortar profile.

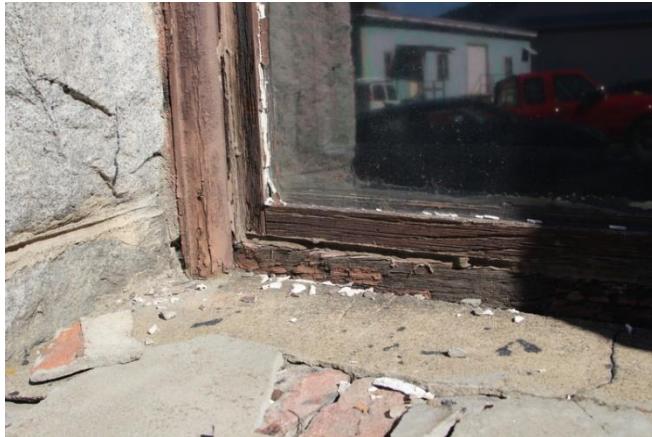
Photo E-5

The windows and doors all appeared to be in fair condition with those on the south-west elevation showing more extensive weathering of the wood frames and finishes, especially at the sills where exposure is the highest (Photos E-5 & E-13). None of the windows were observed to be damaged, though two were altered to accommodate the passage of mechanical equipment (Photos E-6 & E-7). From the interior, it was noted that the window sash were typically missing their sash cords while a lower level window was observed to have been treated with spray foam around the perimeter, likely to improve the thermal performance of the window by reducing air infiltration (Photo E-9). The south-west door was most extensively deteriorated at the base, likely a combination of solar and moisture exposure and potential snow accumulation. The condition of the upper portion and transom of the south-east door is unknown.

Photo E-4
Deterioration of a wood window frame – south-west elevation.

Based on the observations, it is recommended that all of the windows and doors be renewed with the frames being repaired where necessary and all of them being refinished with protective coatings. For historic accuracy, it is recommended that the upper, central, south-east window be reinstated along with the restoration of the granite walls. The south-west door could be restored to match the front or side doors. As part of the contemporary stair addition, the north-west, upper level door should simply be renewed. As an enhanced measure, it is recommended that the functionality of the hung sash windows be restored with the cords and weights reinstated. The operable sash should also incorporate air seals as necessary to maintain the air tightness of the window, while the window frame perimeters should be sealed where necessary, to ensure air flow between the window and wall is minimized. Understanding the mechanical equipment along the south-west elevation is likely to be removed, it is recommended that those windows altered to accommodate the air ducts and vents be restored. The historic appearance of the building would also benefit with a unified storm window profile, selecting either single or double lite frames and making them removable during the warmer times of the year.

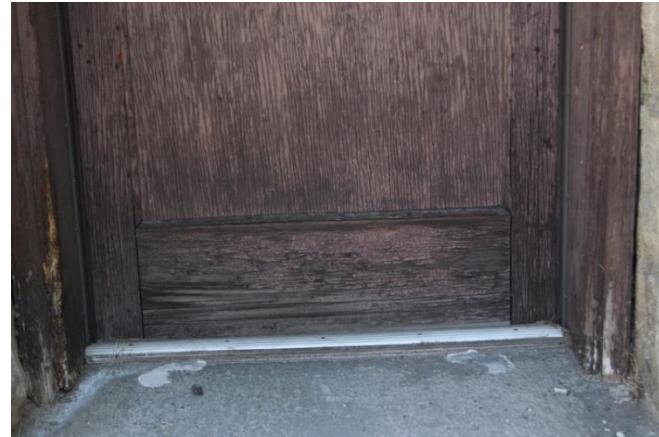
Photo E-13

Deterioration at the base of a door – south-west elevation.

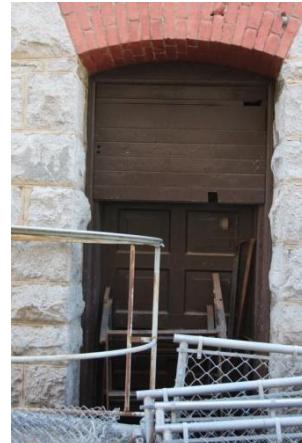
Photo E-14

A partially boarded over 10 panel door similar to the door on the opposite side elevation.

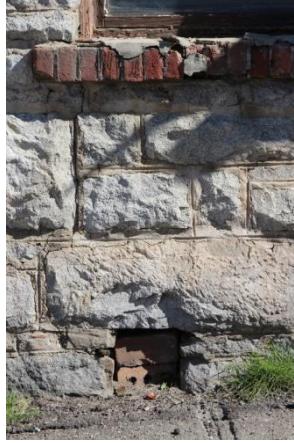
Photo F-6

Table F – Foundation Assembly Observations		
A partially blocked vent at grade connecting the crawlspace to the exterior.

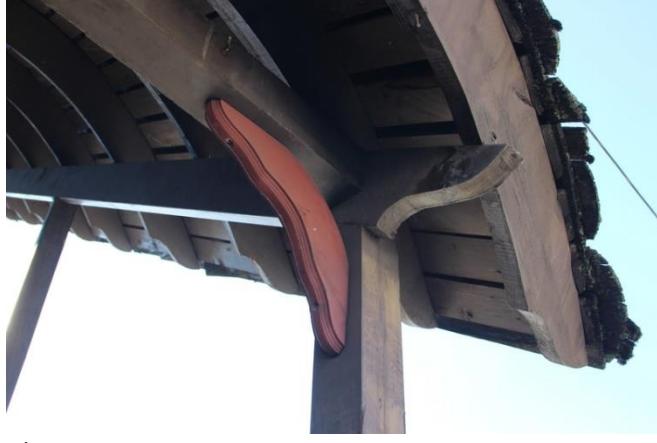
<p>Photo G-5</p>

<p>Photo G-4</p>
<p>The wood frame canopy over the stair.</p>

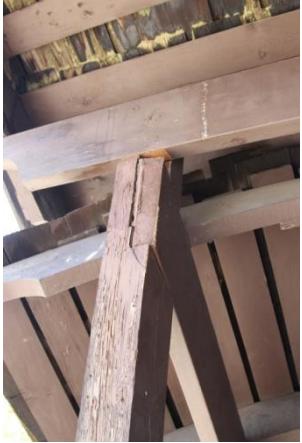
<p>Photo G-8</p>

<p>Photo G-7</p>
<p>A complex framing joint in the upper stair canopy structure.</p>

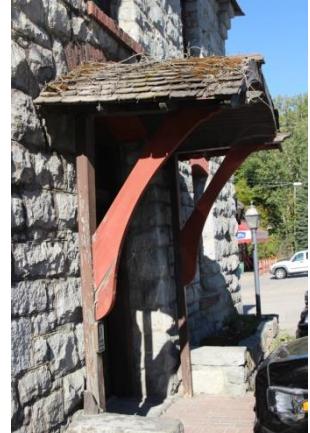
<p>Photo G-11</p>

<p>Photo G-10</p>
<p>The painted support brackets of the front entrance canopy. Note the organic growth on the cedar shingle roof.</p>

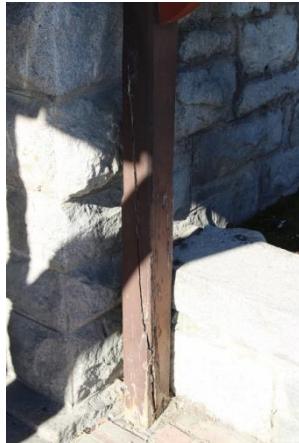
Photo G-14

Photo G-13
A split post supporting the front canopy.

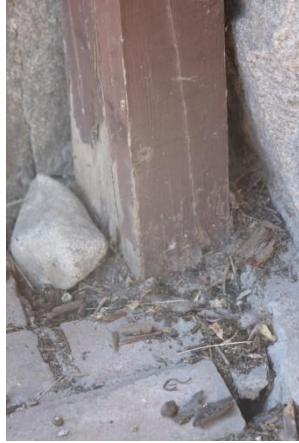
<p>Photo G-15</p>
<p>The back door canopy with a corrugated metal roof.</p>

<p>A deteriorating post base causing the separation between the post and upper beam.</p>

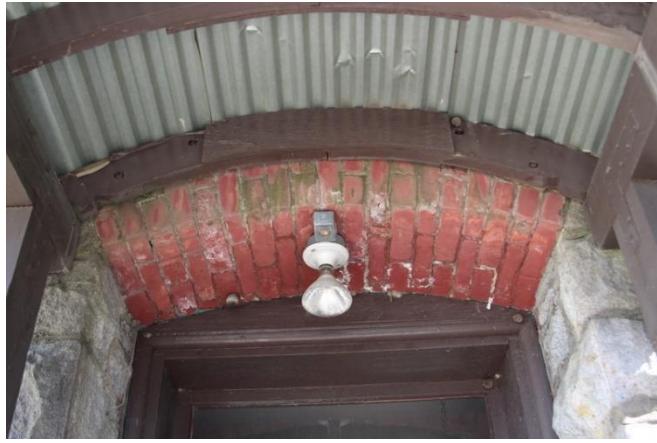
<p>Photo G-17</p>

<p>Photo G-16</p>
<p>The spliced rafters of the back canopy supporting a corrugated metal roof. Note the efflorescence on the masonry arch.</p>

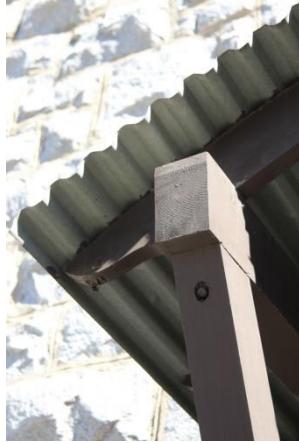
Photo G-18
<p>A twisted and split support post.</p>

Table G – Exterior Attachment Observations	
<p>The contemporary brace and beam with a bolted connection on the back canopy. Note the beam is poorly protected by the roof assembly.</p>

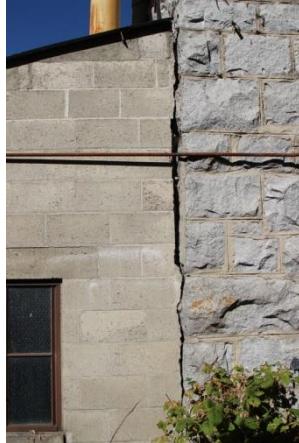
Photo G-22

Photo G-21
<p>A gap between the concrete block structure and the original building suggesting the shed is rotating away from the building.</p>
